Colorado Emergency Watershed Protection (EWP) Program

SH60

Watershed Recovery Project

Final Report

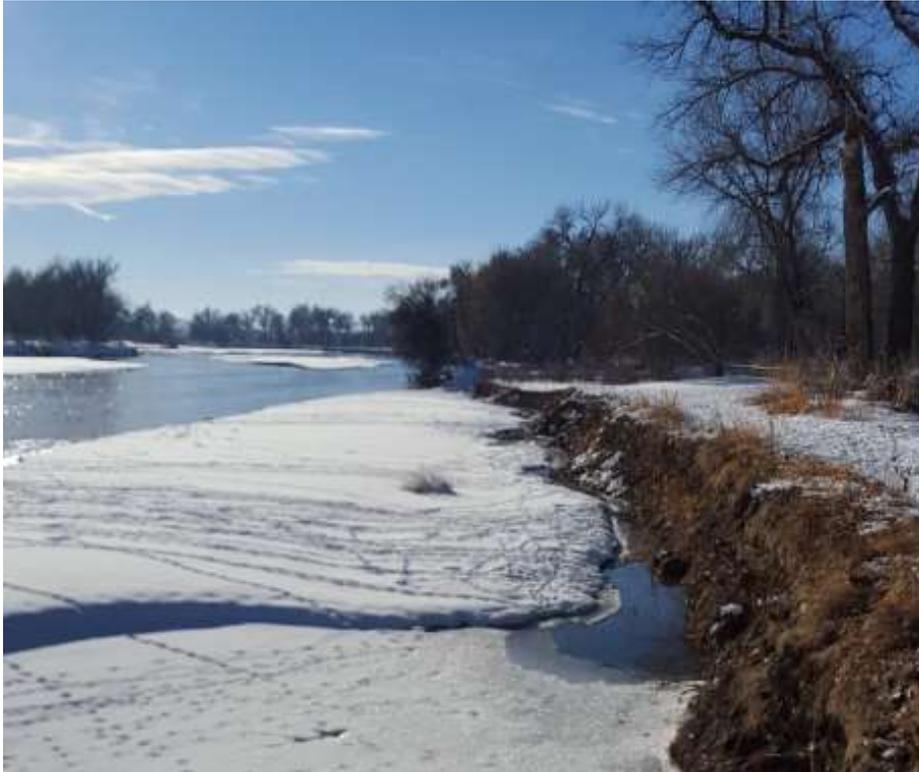
Pre-construction view of the Weir 1 location. Looking west.

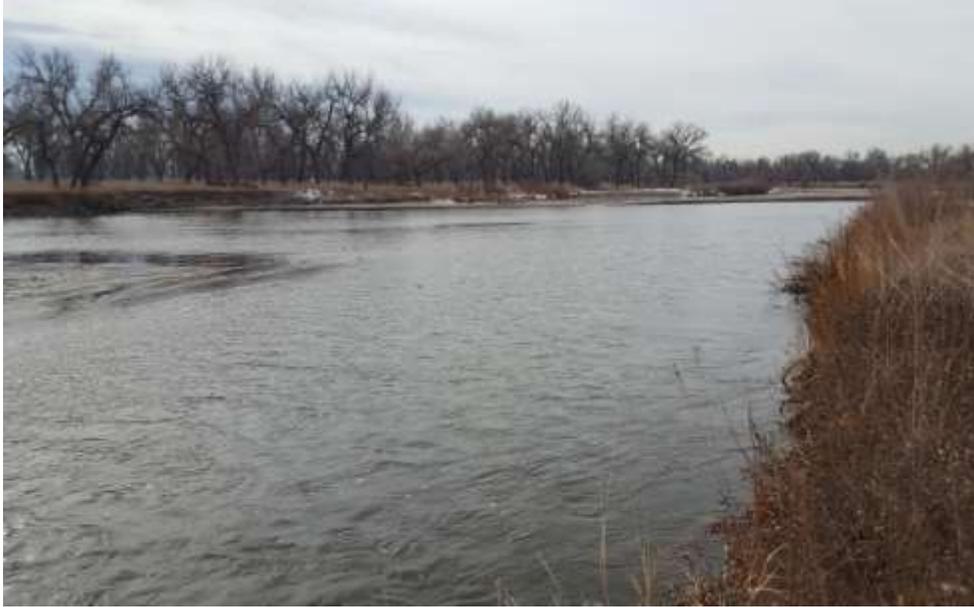
Pre-construction view of weir 2 location looking south west.

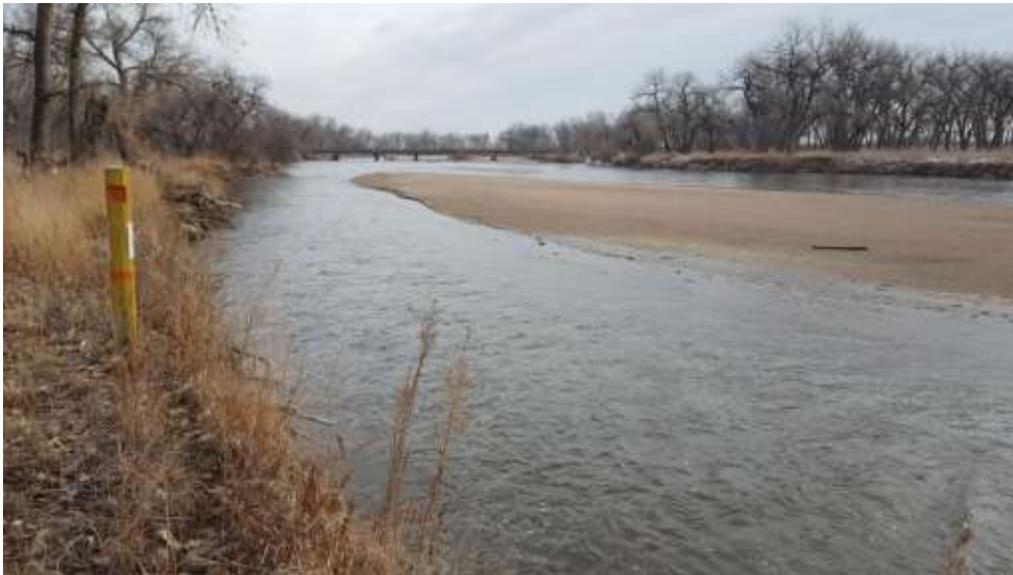
Pre-construction view of the Weir 3 location. Looking east towards SH60 bridge.

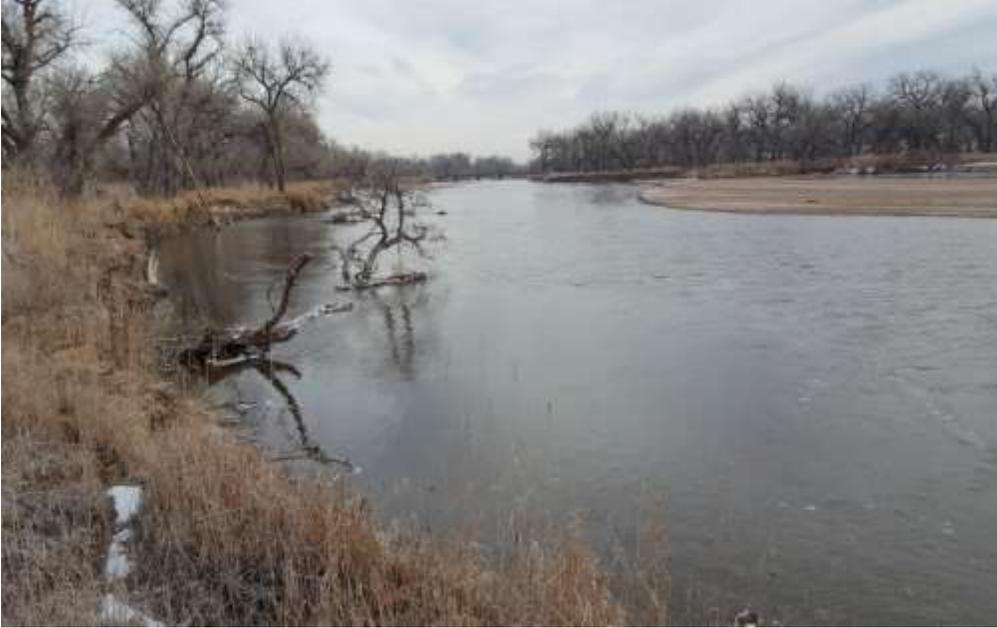
Pre-construction view of the woody toe section. Looking east towards SH60 bridge.

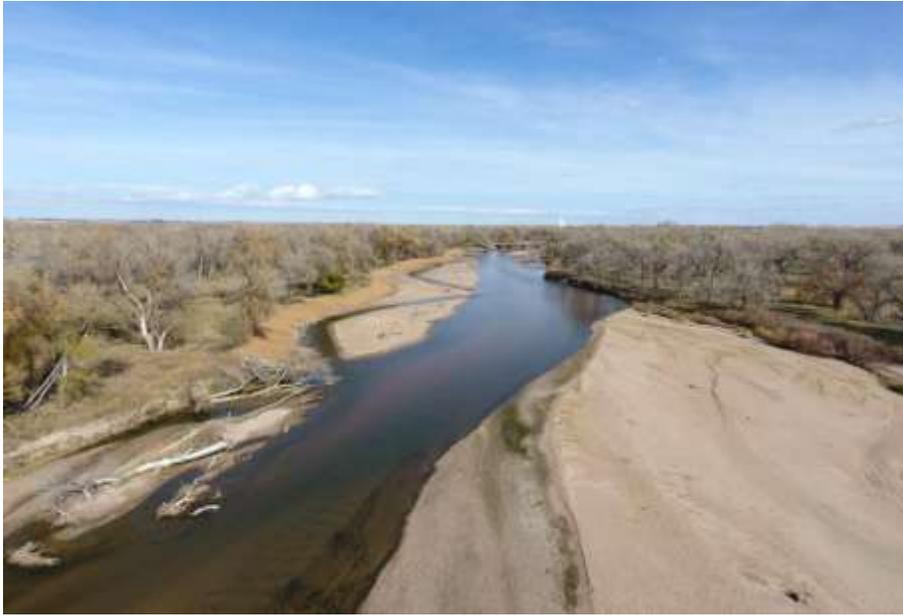
This image is post construction looking east towards the SH60 bridge. This captures the entire project area. The near end of the bank includes the woody toe, and from closest the farthest the weirs can be seen in order from Weir 4, Weir 3, Weir 2 and then Weir 1.

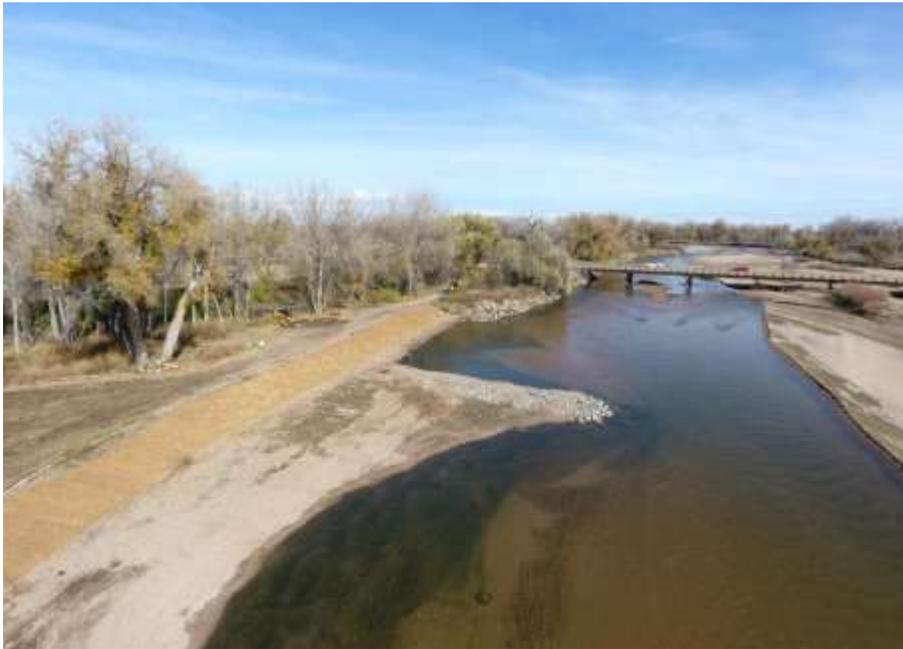
This is an aerial view of Weir 1 and the SH60 bridge.

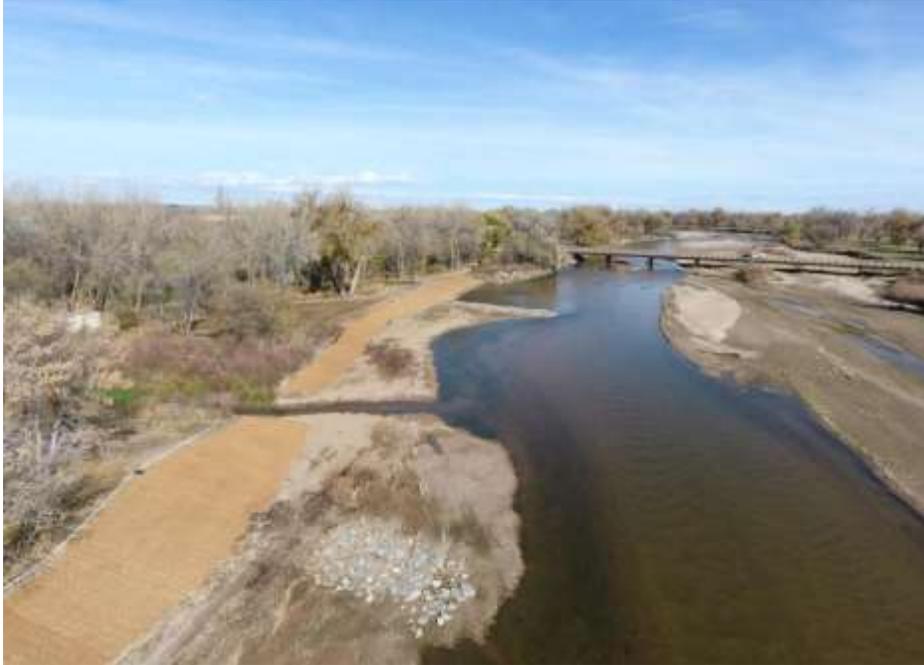
This image shows Weir 2 immediately upstream of the return flow channel from the Kammerzel property.

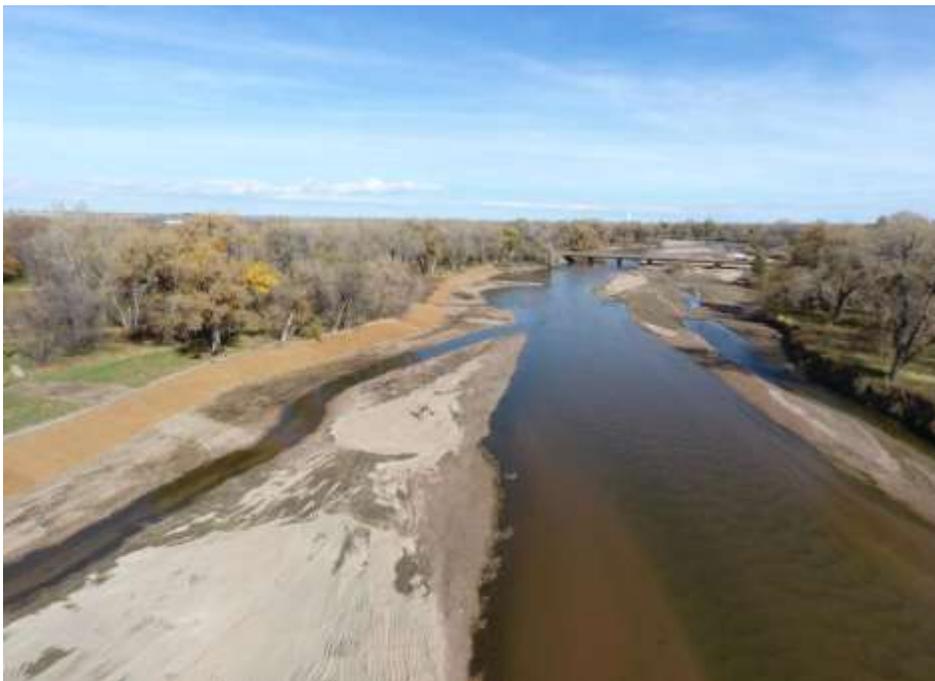
This shows Weir 3 to the north (left as shown) of the sand bar regrading.

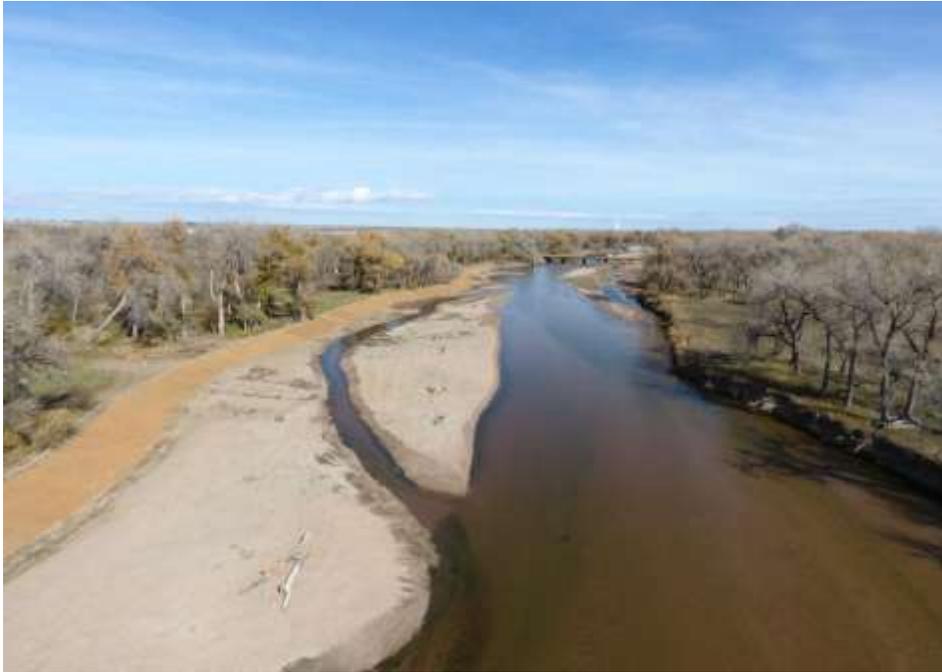
Weir 4 to the north (left as shown) of the sandbar
